# Power Cut at PIC Tier1

Date start: 21<sup>st</sup> May 2010 at 13:40 UTC

Date end: 22<sup>nd</sup> May 2010 at 9:00 UTC

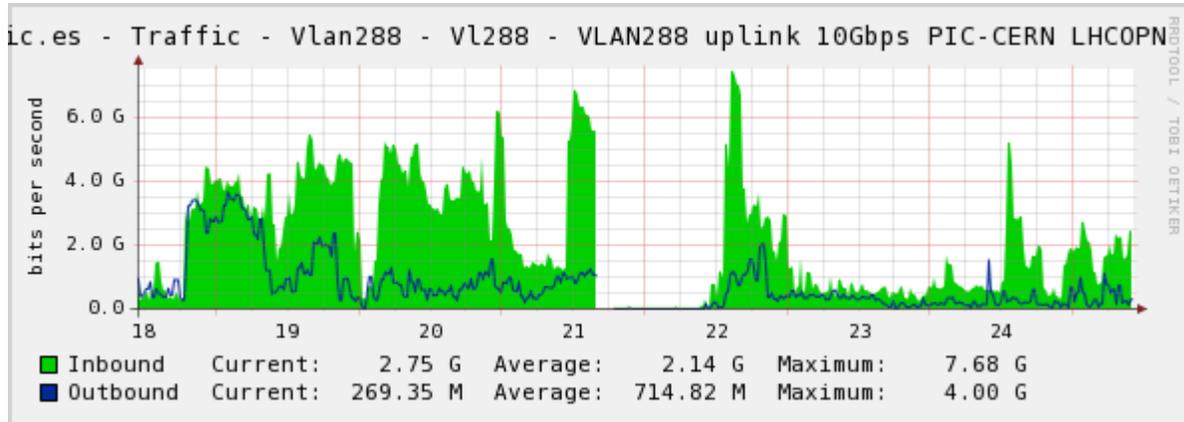
Fig 1: Weekly network traffic in the PIC OPN link. The power off time interval (in CET) is clearly seen. The high network traffic taking place when the power off occurred was an ATLAS massive data replication that was taking place. After service start up on Saturday 22<sup>nd</sup> it can be seen that the data replication resumed at very high rate and backlog could be recovered.

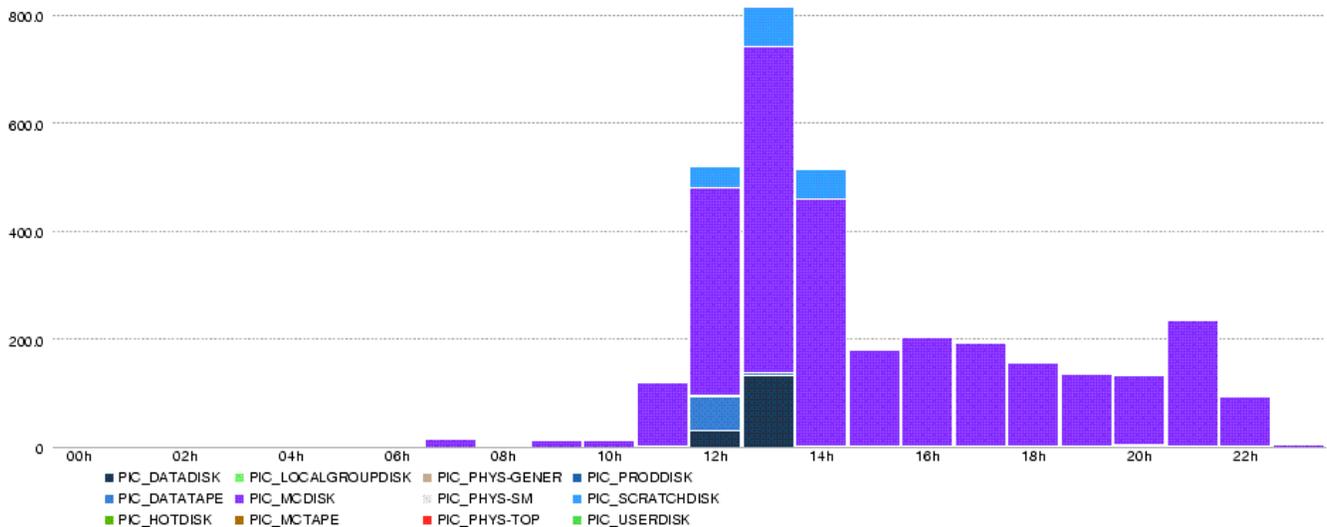
Fig 2: Detail of the hourly import data rate to PIC (in MB/s) on Saturday 22<sup>nd</sup> from the ATLAS DDN dashboard.

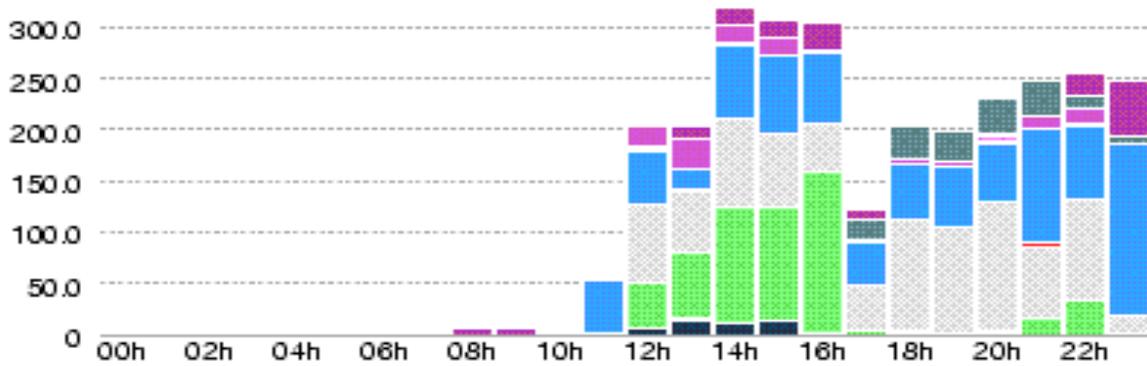
Fig 3: Detail of the hourly export rate in MB/s from PIC to the ATLAS ES Tier2 cloud showing that the data distribution activity was resumed shortly after the service recovery with high performance.
