ATLAS HGTD Preliminary

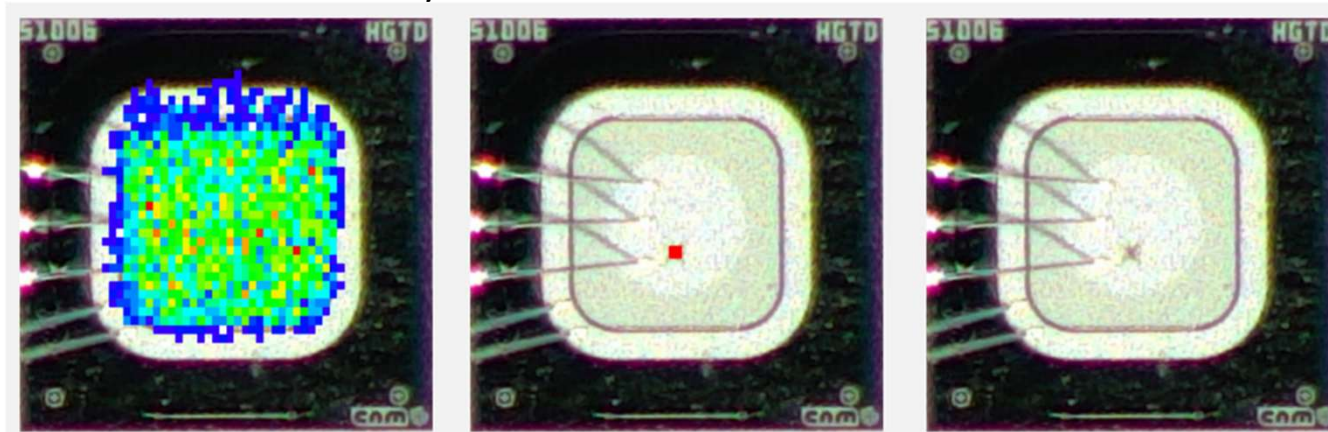
Typical Single Event Burnout mark is shown in the right plot (2019 DESY test-beam with 5 GeV e). The reconstructed track in the SEB event pointed to the location of the burn mark (middle and right plot). All the reconstructed tracks distribution across the detector before SEB is shown in the left plot.
