EDMS NO. 2187999	REV. 001	VALIDITY

Results of exposure of Festo PUN-H 8mm (Blue) Plastic Tube to Novec 649

This document summarises the discovered degradation of the Festo PUN-H Blue Plastic Tube after exposure to Novec.

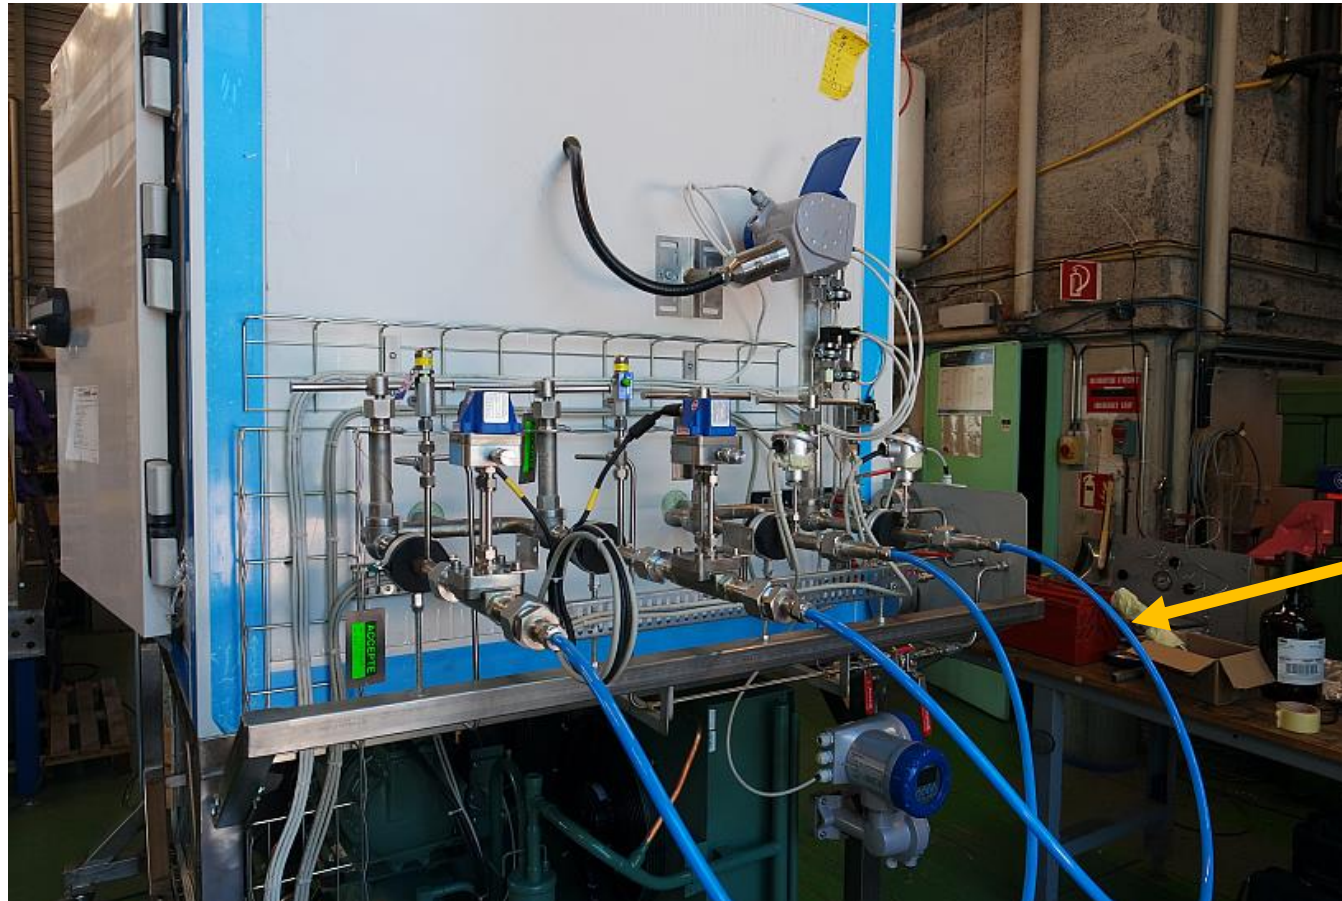
The tube being used during commissioning of LHCb Baby Demo in summer 2018

The tubes
in use on
the LHCb
Baby Demo

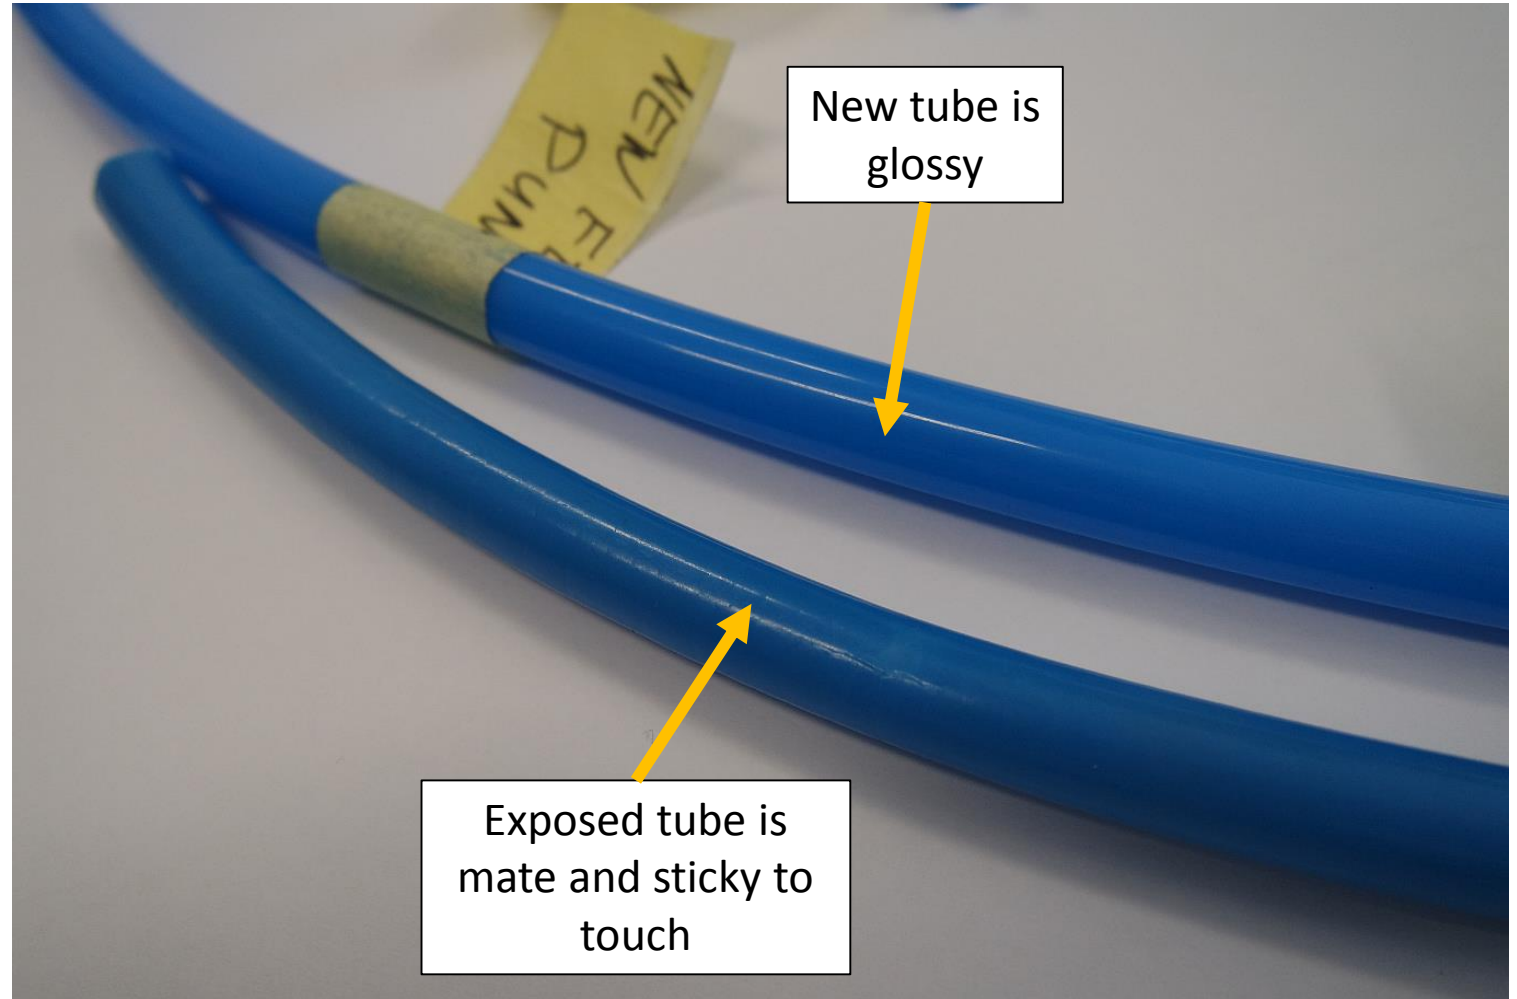
Tube surface

- The tube is matte (it used to be smooth, shiny and glossy)
- The tube is sticky to touch
- The tube is easy to break when bended/folded excessively (new tube does not break even though it gets damaged when bended/folded excessively)
- The tube cracks when squished (new tube gets damaged but it does not crack)

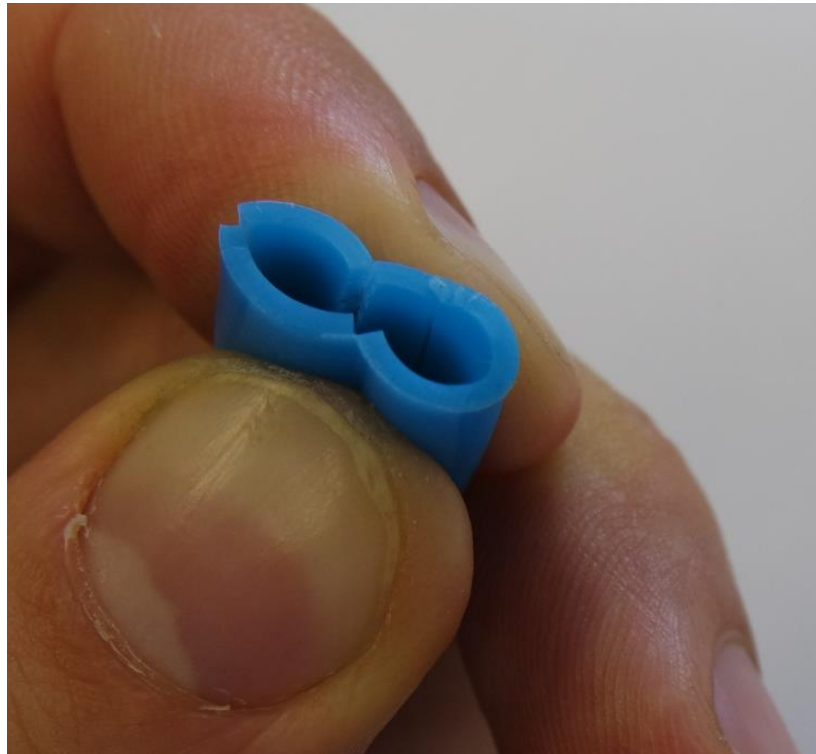
Squish test

Fully Squishing the tube between fingers

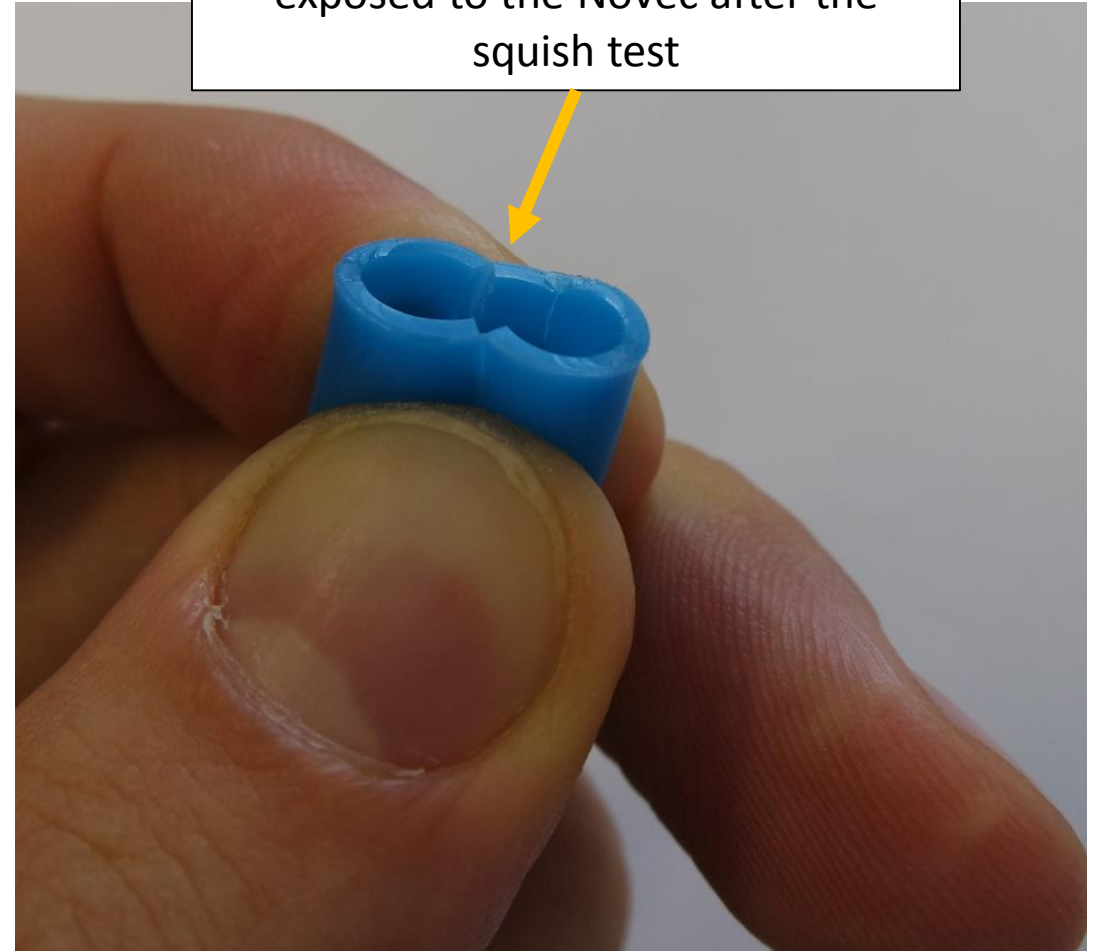
Many cracks developed on the tube exposed to the Novec after the squish test
